Environmental outcomes of seismic surveying in the Coongie Lakes Control Zone

David Cockshell (Chief Petroleum Geophysicist, Petroleum Group, PIRSA)

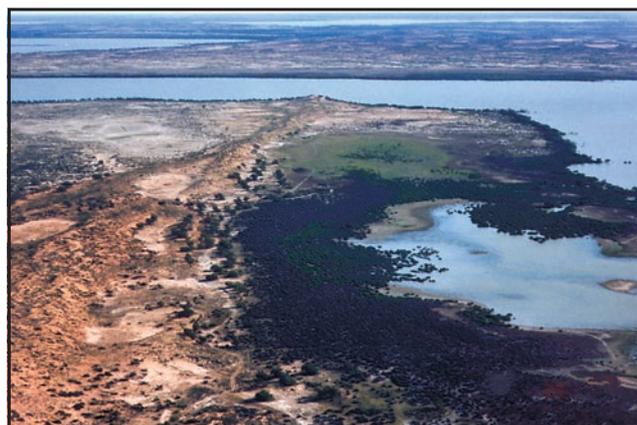
Seismic line near Lake Marroocutchanie, view north. (Photo 46517)

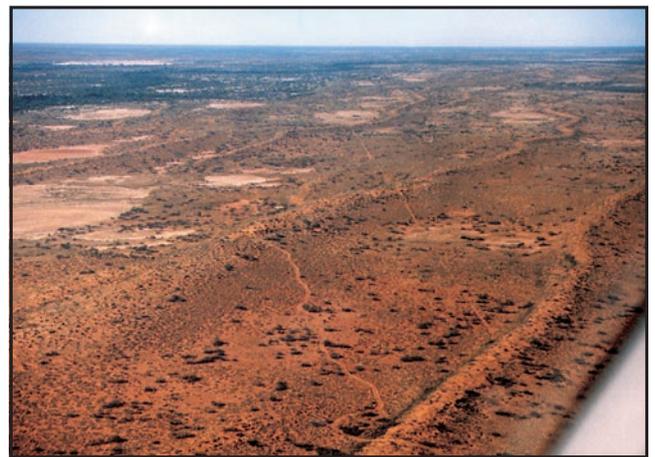
Comparison of a new seismic line at left with the straight 1977 line, view south. (Photo 46518)

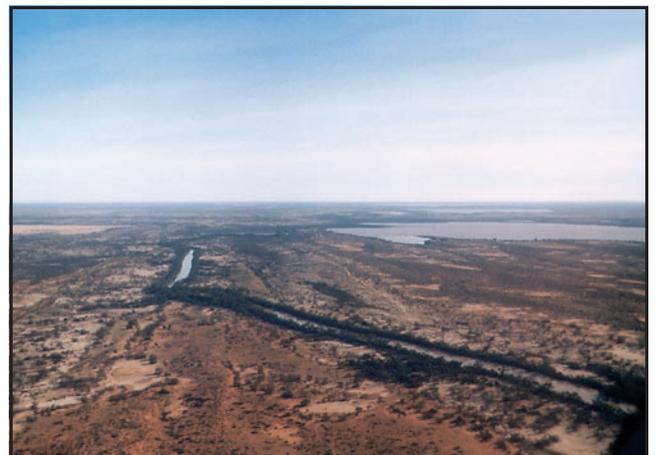
Northwest branch of Cooper Creek and Coongie Lake, view north. The Coongie Track is clearly visible between the creek and the lake. A seismic line in the centre foreground is difficult to discern. (Photo 46519)
